LAKE CLASSIFICATION REPORT FOR WOLF LAKE, ADAMS COUNTY

**Presented by Reesa Evans, Lake Specialist
Adams County Land & Water Conservation Department
P.O. Box 287, Friendship, WI 53934**

JANUARY 2008

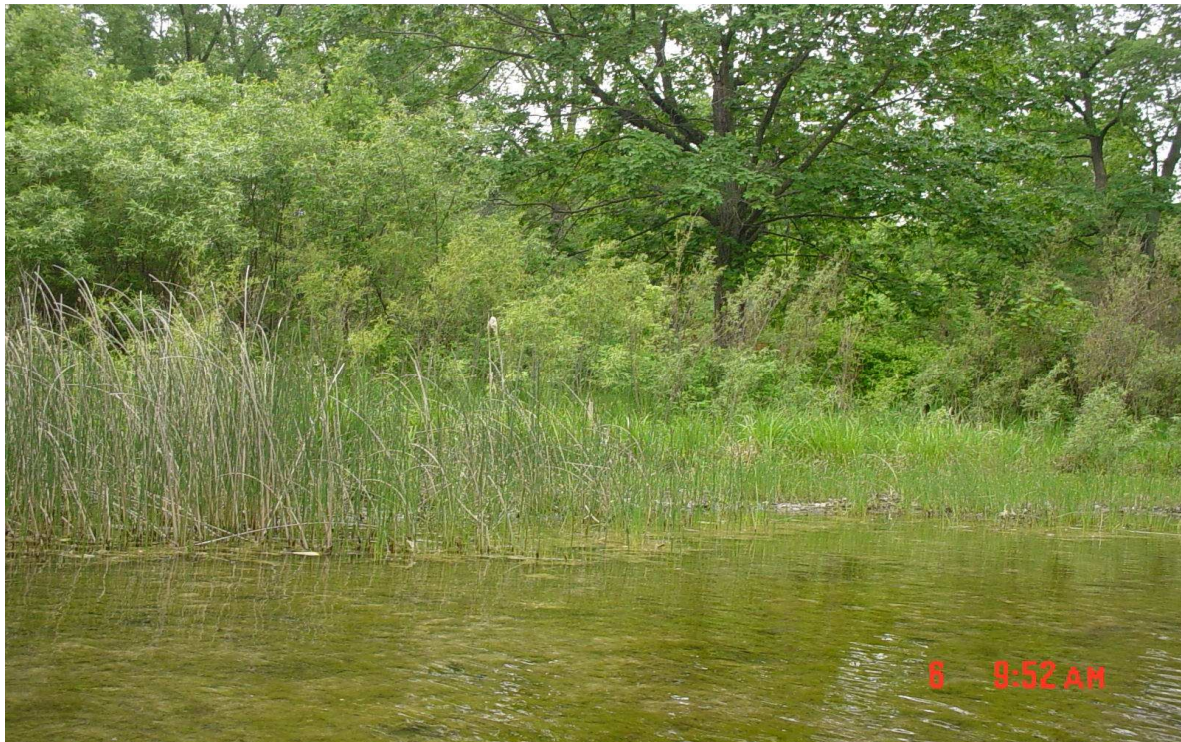
Figure 8: Wolf Lake shore wetland

The photo above (Figure 8) shows one of the wetlands along the shore of Wolf Lake. Looking at the map of wetlands directly around Wolf Lake (see Figure 9) makes it evident how important wetlands are to Wolf Lake...more than 1/3 of the lake has wetlands at or near the shore that serve as filters and trappers that help keep the lake as clean as it is. It is essential to preserve these wetlands for the health of Wolf Lake.

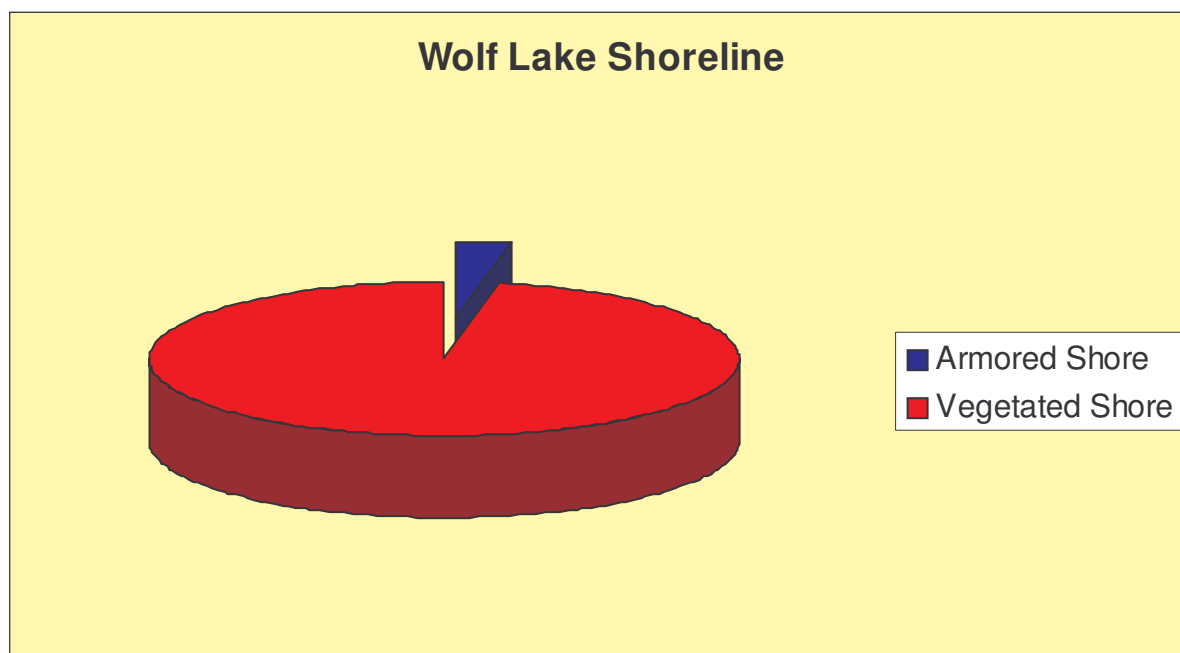
Figure 11: Wolf Lake Shores Status

The Adams County Land & Water Conservation Department conducted a survey of the Wolf Lake shoreline in 2004. Shore types were categorized as "armored" and "vegetated". "Armored" shores included seawalls of any material and rock riprap and are only about 219 feet of Wolf Lake's shore. "Vegetated" shores encompassed both native vegetation of any type and traditional mowed lawns and covered 7173 feet of shore (see Figure 11).

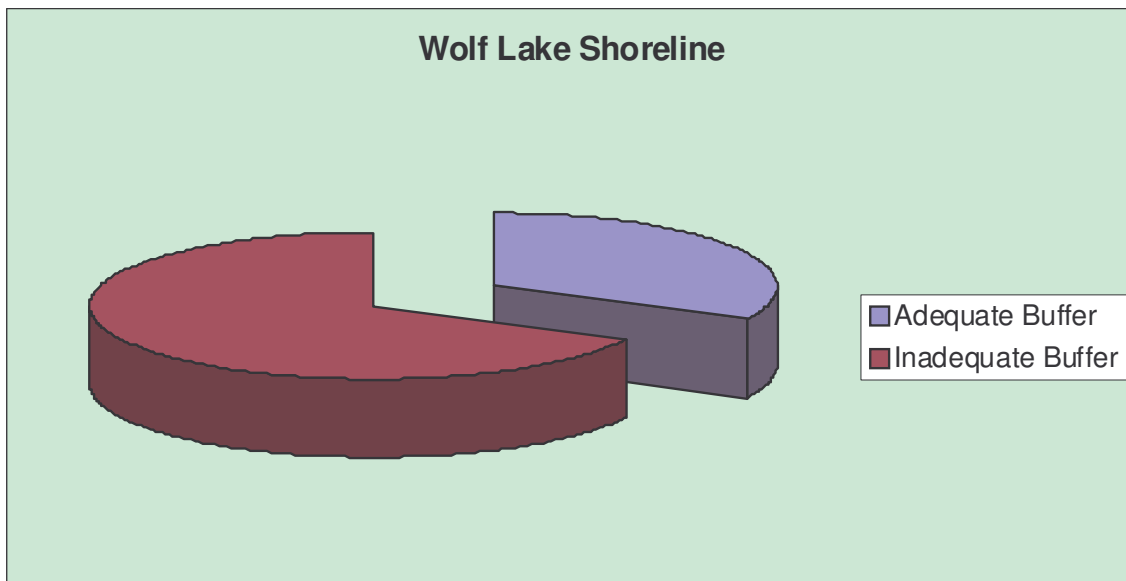
Figure 14: Buffer Categories on Wolf Lake

The 2004 inventory included classifying areas of the Wolf Lake shorelines as having “adequate” or “inadequate” buffers (see Figure 14). An “adequate” buffer was defined as one having the first 35 feet landward covered by native vegetation. An “inadequate” buffer was anything that didn’t meet the definition of “adequate buffer”, including native vegetation strips less than 35 feet landward. Using these definitions, 32.6% (about 2510 feet) of Wolf Lake’s shoreline had an “adequate buffer”, leaving 67.4% (4882 feet) as “inadequate.” Most of the “inadequate” buffer areas were found with traditional mowed lawns and/or insufficient native vegetation at the shoreline to cover 35 feet landward from the water line.

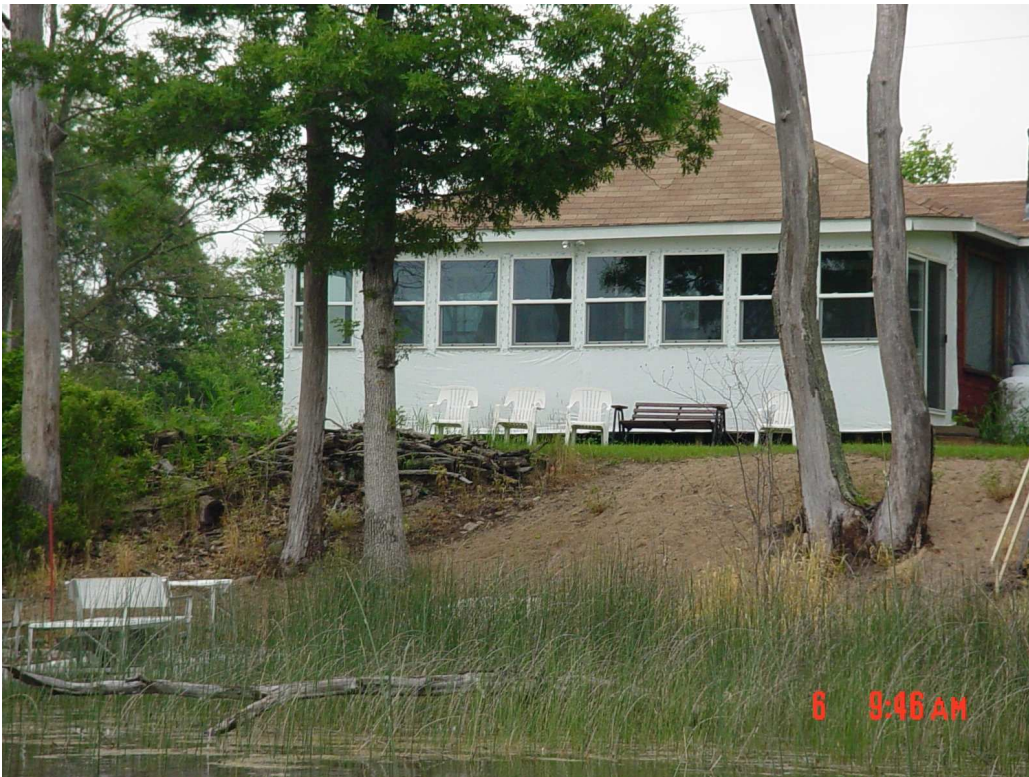
Figure 16: Inadequate Vegetative Buffer on Wolf Lake

When the natural shoreline is replaced by traditional mowed turf-grass lawns, rock, wooden walls or similar installments, bird and animal life, land-based insects, and aquatic insects that hatch or winter on natural shore are negatively impacted. For example, on many Adams County lakes, the non-native aquatic plant, Eurasian Watermilfoil has invaded. There is a weevil native to Wisconsin that weakens Eurasian Watermilfoil by burrowing into and developing within its stems, but that weevil depends on a native-plant shore to overwinter. If the shore is instead covered by rock, seawall or traditional lawn, these weevils will be unavailable for the lake to use as Eurasian Watermilfoil control.

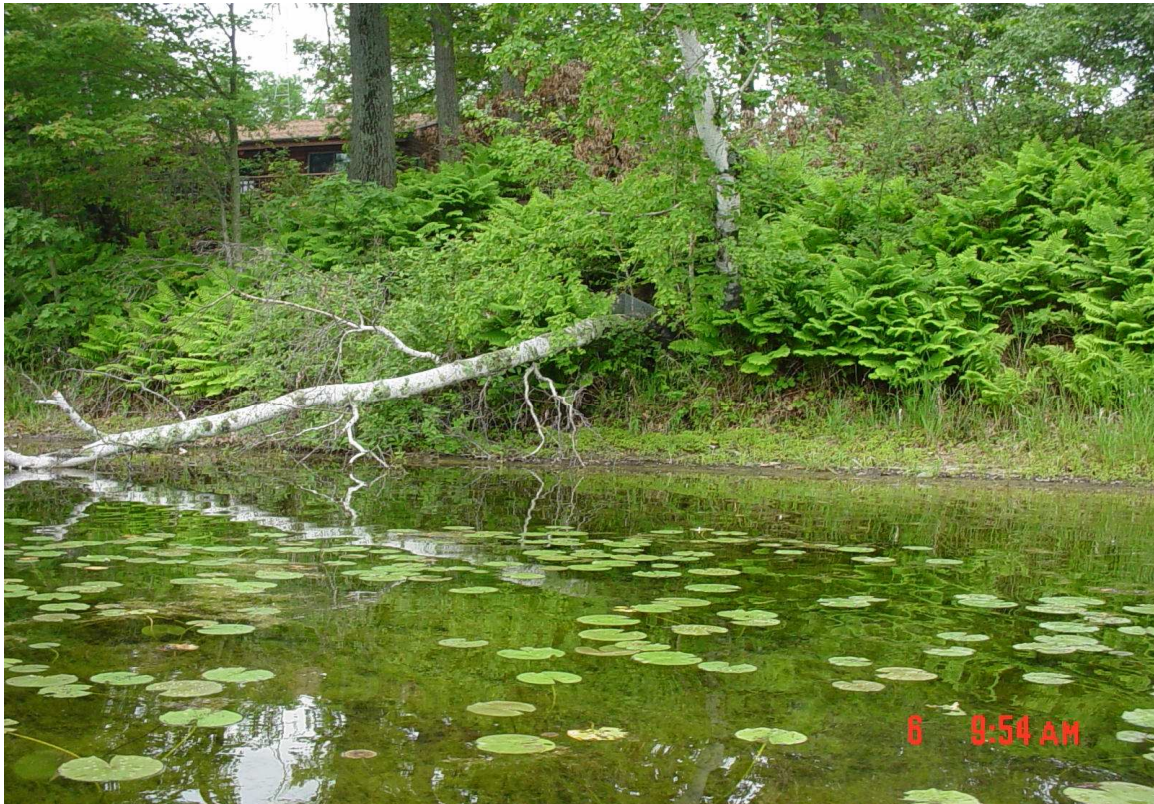
Figure 17: Adequate Buffer on Wolf Lake

The filtering process and bank stabilization that buffers provide help improve a lake's water quality, including water clarity. Studies in Minnesota, Maine and Michigan have shown that waterfront property value increases for every foot the water clarity of a lake increases. (Krysel et al, 2003).

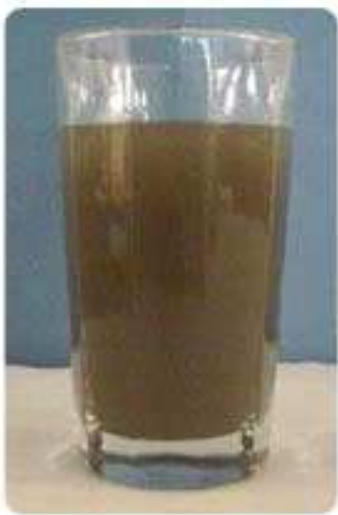
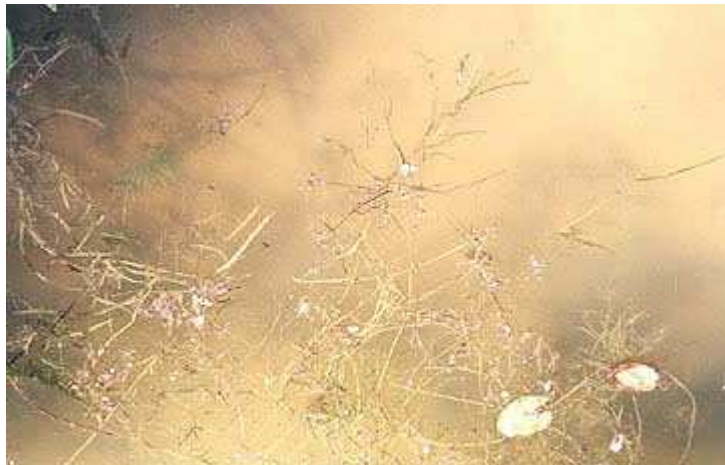
Figure 37:
Examples of Very
Turbid Water

TURBIDITY: Turbidity reflects water clarity. The term refers to suspended solids in the water column—solids that may include clay, silt, sand, plankton, waste, sewage and other pollutants. Turbid water may mask the presence of bacteria or other pollutants because the water looks murky or muddy. In general, turbidity readings of less than 5 NTU are best. Very turbid waters may not only smell, but also tend to be aesthetically displeasing, thus curtailing recreational uses of the water. Turbidity levels for Wolf Lake's waters were 1.85 NTU in 2004, 1.5 NTU in 2005, and 1.9 NTU in 2006—all very low levels.

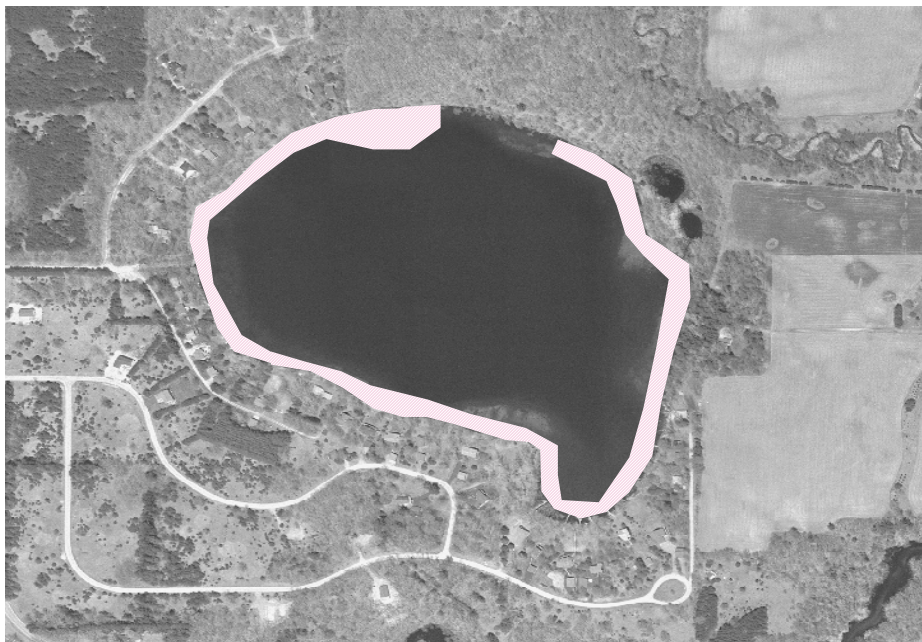
Figure 46a: Emergent Aquatic Plants in Wolf Lake 2005

Emergent Plants Found 2005

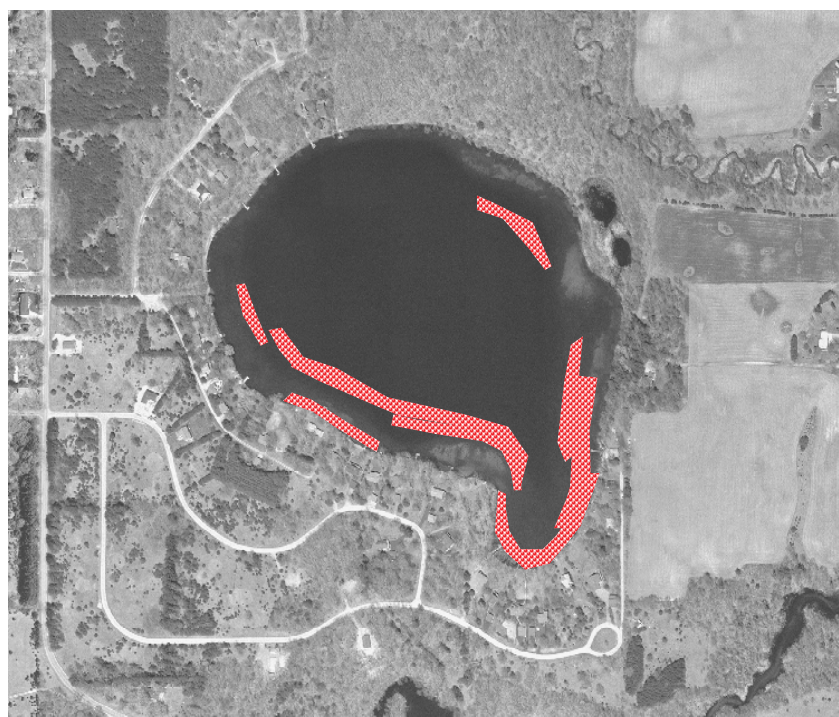
Figure 48: Distribution of Exotic Aquatic Plants in 2005

Eurasian Watermilfoil was introduced in Wolf Lake, but since chemical treatments (targeting milfoil wherever it is found in the lake) began in 2002, the acreage of milfoil requiring treatment has declined. In July 2005, Eurasian Watermilfoil was a commonly occurring species, but occurred at below average densities and was abundant only at depths greater than 10 feet, occurring at the maximum rooting depth between 10' and 20' depth with *Elodea canadensis*. It was not found along the north shore. Its recurrence in the deeper areas and coverage of approximately 8 acres by July 2005 is likely due to the problem of decreasing chemical effectiveness with deeper water. The Wolf Lake Association expects to continue monitoring the Eurasian Watermilfoil population and take necessary treatment steps to keep it managed.

Exotic Plants Found 2005

Curly-Leaf Pondweed was also found in Wolf Lake in 2005, but only at two sites in water 10' to 20' deep. Although it is present, it does not appear in either high frequency or density. Purple Loosestrife was also found on the shore of Wolf Lake in 2005—two plants were noted at one shore site just to the left of the boat ramp entry. Members of the Wolf Lake Association were notified of its presence. They pulled the plants by hand, being sure to remove all parts of the plant. It does not appear that Purple Loosestrife is a significant problem at Wolf Lake at this time. However, ongoing monitoring for both of these plants should occur.

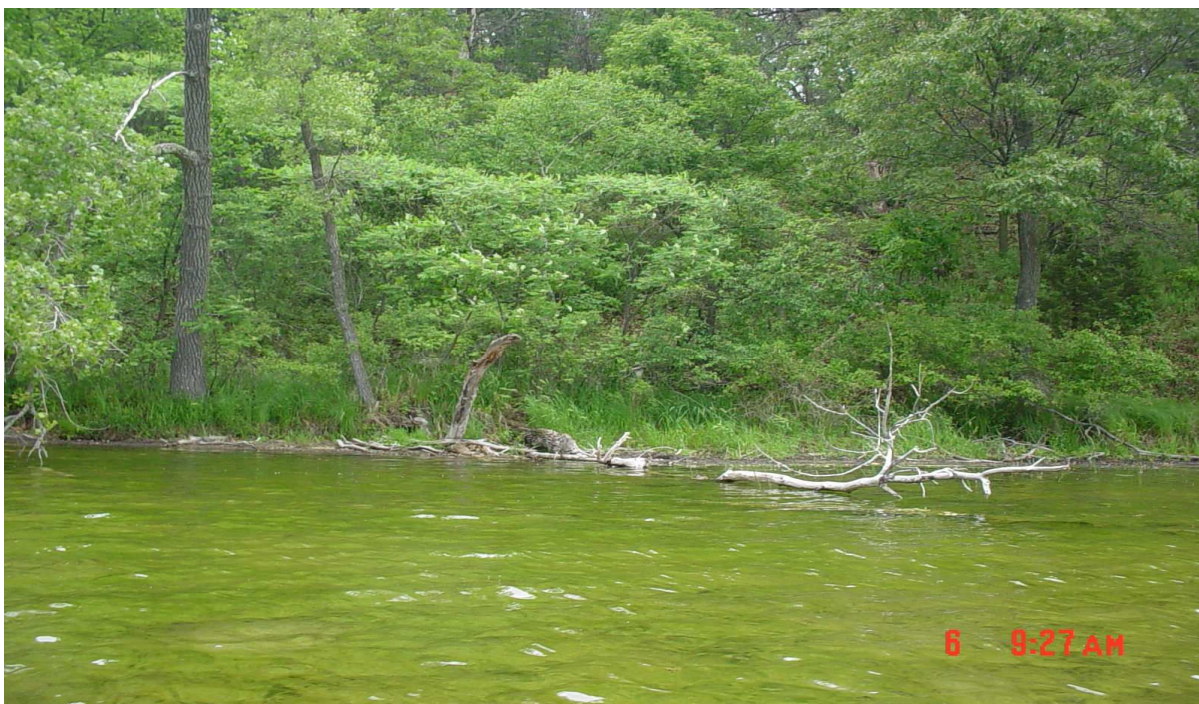
Figure 52: Photo of Point A in Area WL1, Wolf Lake

This area of large woody cover, emergent aquatic vegetation, submergent and floating vegetation provides spawning and nursery areas for many types of fish: northern pike; largemouth bass; rock bass; bluegill; pumpkinseed; yellow perch; crappie; bullhead; and other panfish. All of these fish also feed and take cover in these areas. No exotic aquatic wildlife was noted in this area, i.e, no carp, smelt or rusty crayfish were seen. Filamentous algae were found at this site.

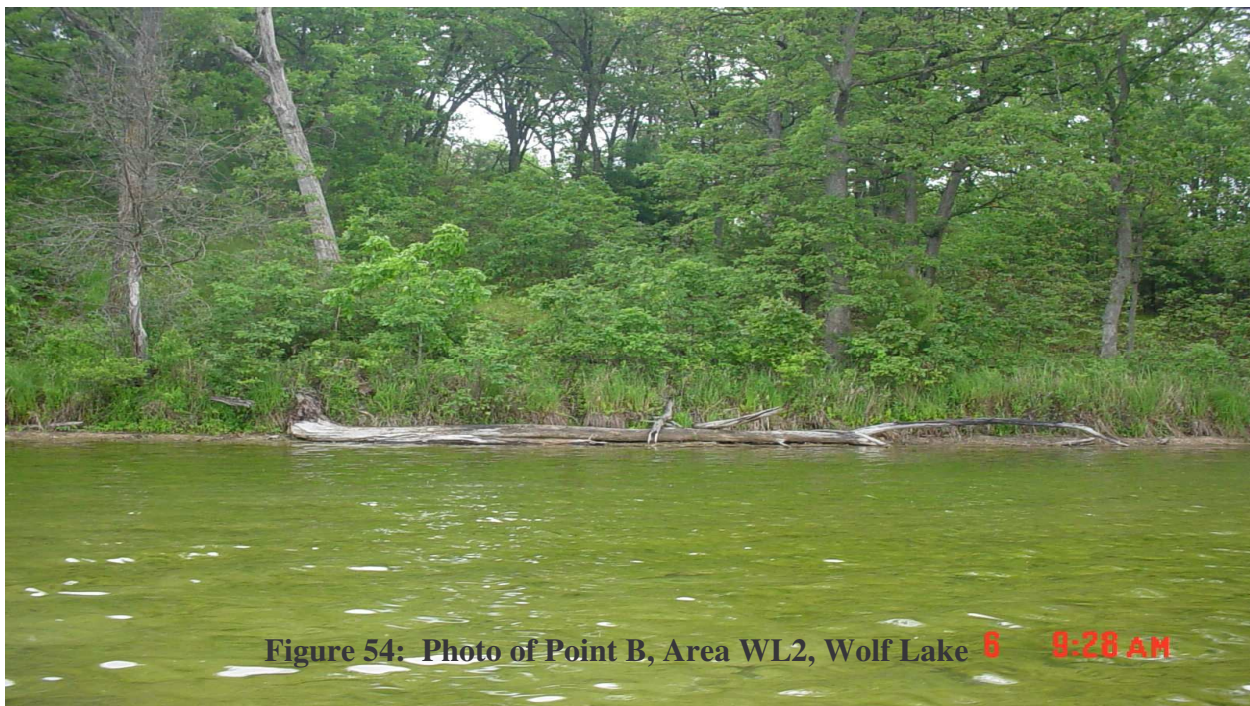
Figure 54: Photo of Point B, Area WL2, Wolf Lake 8 8:28 AM

The abundant large woody cover, as well as emergent aquatic vegetation, submergent and floating vegetation, provides spawning and nursery areas for many types of fish: northern pike; largemouth bass; bluegill; pumpkinseed; yellow perch; crappie; bullhead; suckers, other panfish. These fish also feed and take cover in these areas. No exotic aquatic wildlife was noted in this area, i.e, no carp, smelt or rusty crayfish were seen. No shore development was present.

Seen were various types of waterfowl and songbirds, as well as turtles and snakes. A pair of eagles has nested here for the past several years. Frogs were heard. This wildlife nests and feeds here, as well as using the vegetation for cover or shelter. Downed logs serving as habitat were also seen. Muskrat and mink are known to use WL2 for cover, reproduction and feeding. Upland wildlife feed and nest here as well. Since human disturbance is absent in WL2, it provides high-quality habitat for many types of wildlife.

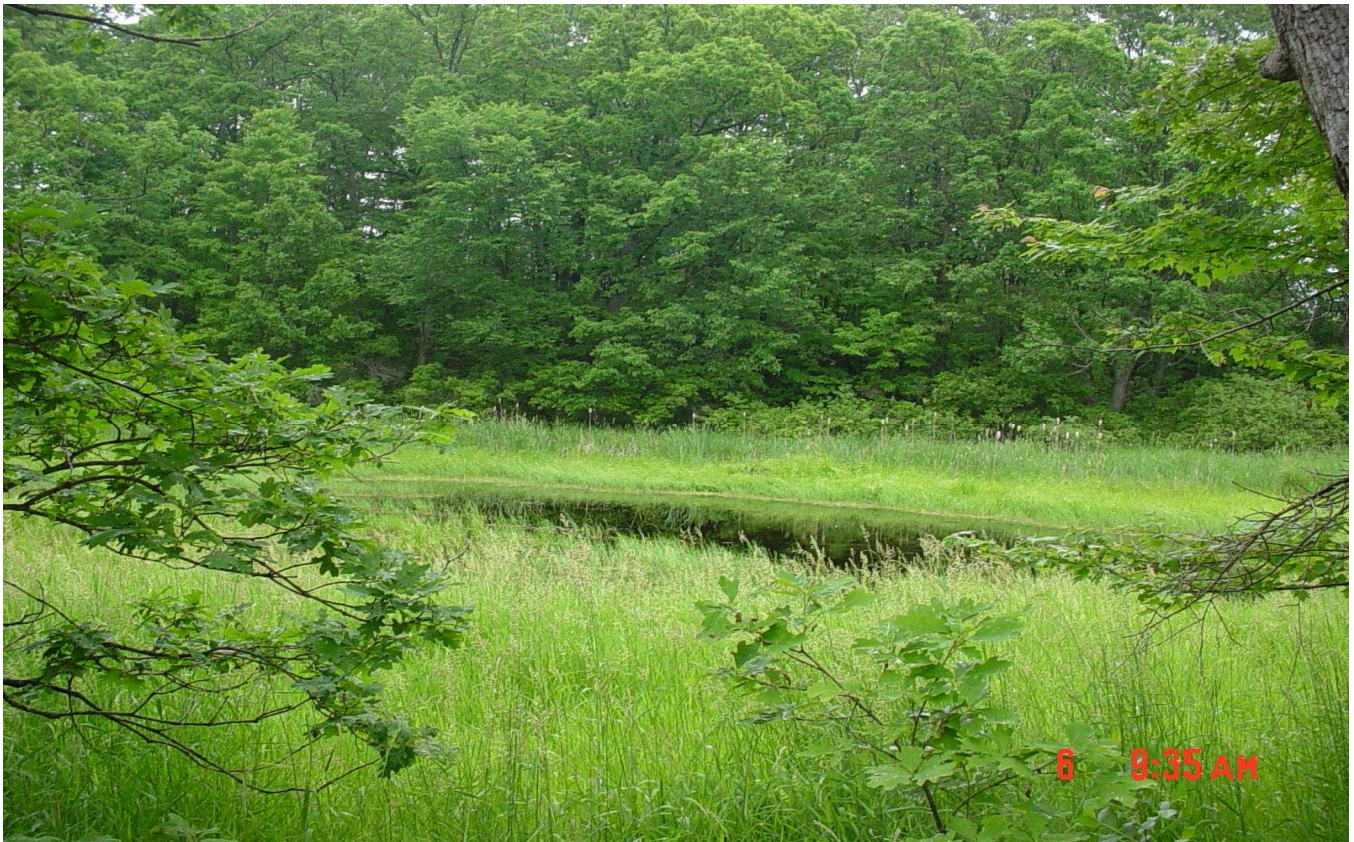
Figure 56: Photo of Area D, Area WL2, Wolf Lake

No threatened or endangered species were found in this area. Three exotic invasives, *Myriophyllum spicatum* (Eurasian watermilfoil), *Phalaris arundinacea* (Reed Canarygrass) and *Potamogeton crispus* (Curly-Leaf Pondweed), were found in this area. Filamentous algae were found, especially near the shores.
